WALLMARK LAKE TMDL SUMMARY

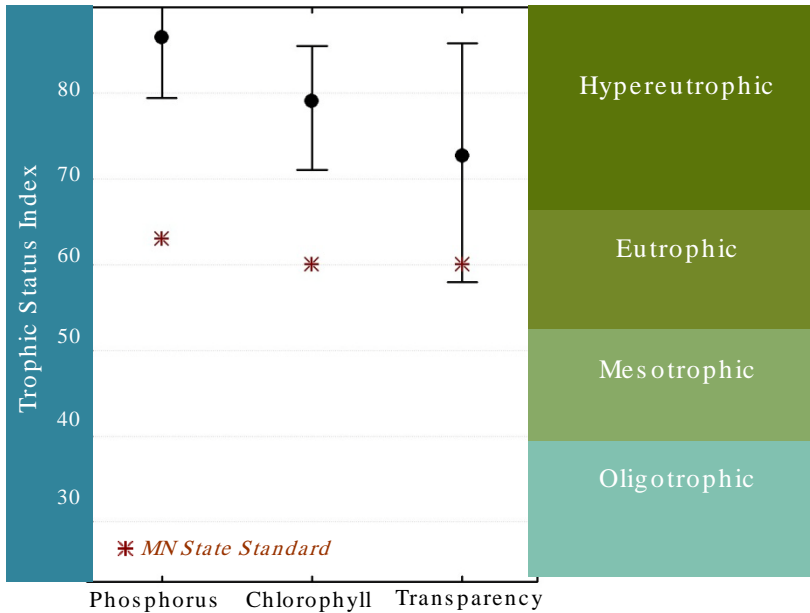
Observed Water Quality

Mean and Range of Annual Averages (2001, 2006, 2009, 2010)

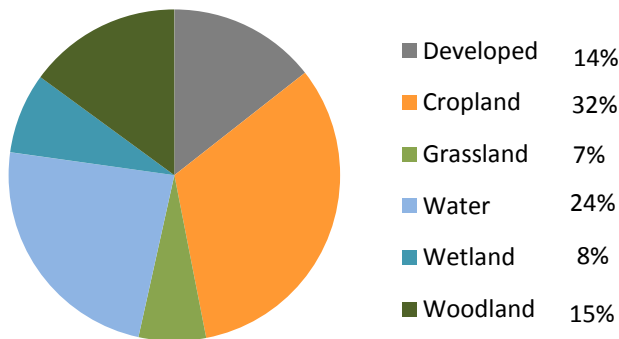
Wallmark Lake

Land Cover
